NATIONAL AERONAUTICS AND SPACE ADMINISTRATION

APOLLO 13 MISSION REPORT

MANNED SPACECRAFT CENTER

SEPTEMBER 1970

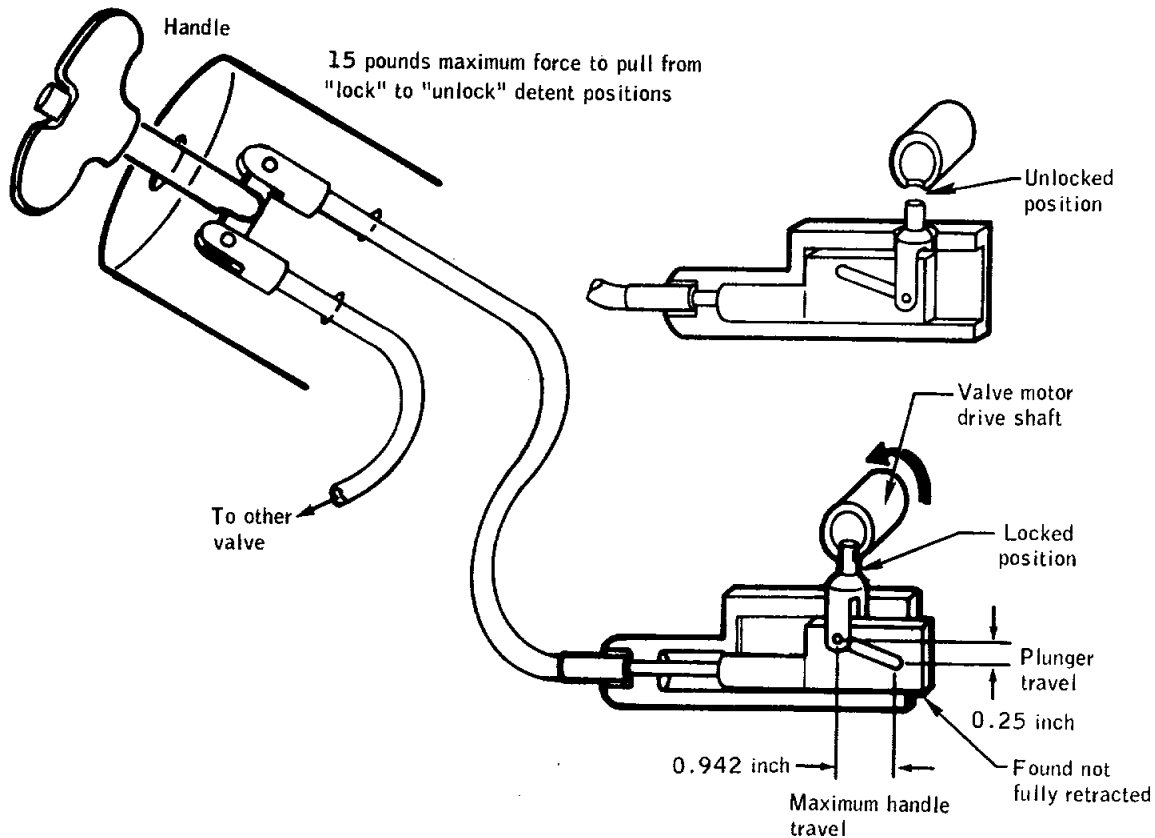
Figure 14-1.- Post-landing vent valve lock.

Upon recovery, the outlet valve of the postlanding ventilation was open and the inlet valve was closed, whereas both valves should have been open. This condition is reported in section 10.3.2, and the anomaly is discussed in section 14.1.2.

The valve-lock mechanism rigging tolerances were found to be within specifications. When reassembled in the spacecraft, the malfunction was duplicated with only partial travel of the handle.

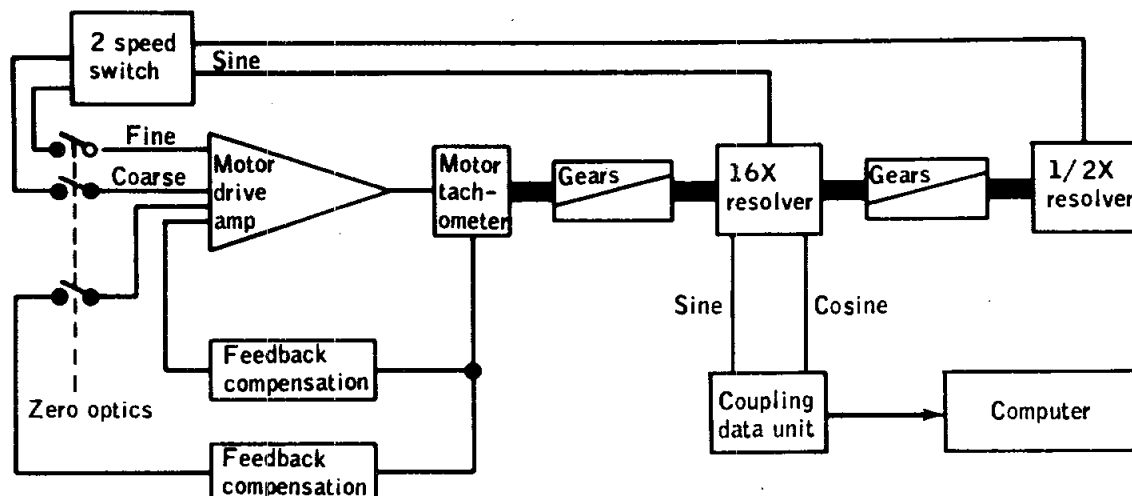
Figure 14-2.- Zero optics mode circuitry.

Performance of the guidance, navigation, and control system was normal except for two instances. Random motion observed in the sextant shaft during the zero optics mode was operationally prevented by turning off power to the optical system when not in use. This problem occurred during Apollo 12 and is thought to be caused by a buildup of contact resistance in the slip rings of the half-speed resolver in the sextant (section 14.1.3). The crew reported the 0.05g light did not illuminate as required within 3 seconds after the digital computer had indicated 0.05g. A manual procedure was therefore required to start the entry monitor system, which performed nominally throughout the remainder of entry (section 14.1.5). As a result of the aborted mission, all power was removed from the inertial platform, including heaters, for approximately 80 hours. After powering up and coarse aligning the platform to that of the lunar module, the command module was guided to a successful landing within approximately 1 mile of the target location. Because of power restrictions, the circuit breaker for the data storage equipment recorder was left open during entry, and no entry data are available for an entry performance analysis.

the half-speed and 16-speed resolvers are routed through a coarse/fine switching network to the motor drive amplifier and are used to null the system. Rate feedback from the motor tachometer is routed to the drive amplifier through a compensation network which removes any bias in the signal. When the zero optics mode is selected, the coupling-data-unit counter and the computer register which contains the shaft angle are zeroed for 15 seconds and then released to follow the 16-speed resolver. The half-speed resolver, the fine/coarse switching network, and the tachometer feedback compensation are used only in the zero optics mode.

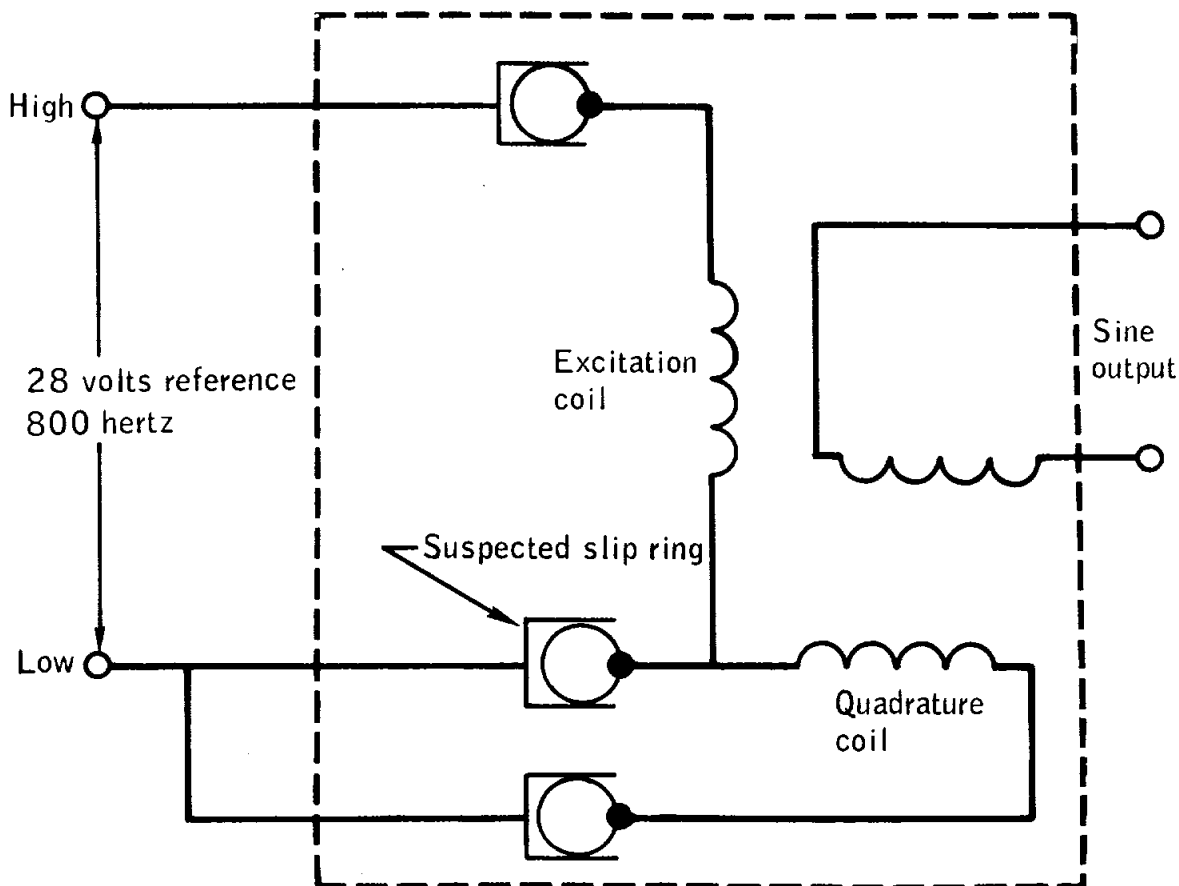
Figure 14-4.- One-half speed resolver.

vacuum testing. The tests were run with the units rotating at 1 rpm, however, and the momentary resistance changes disappeared with the wiping action.

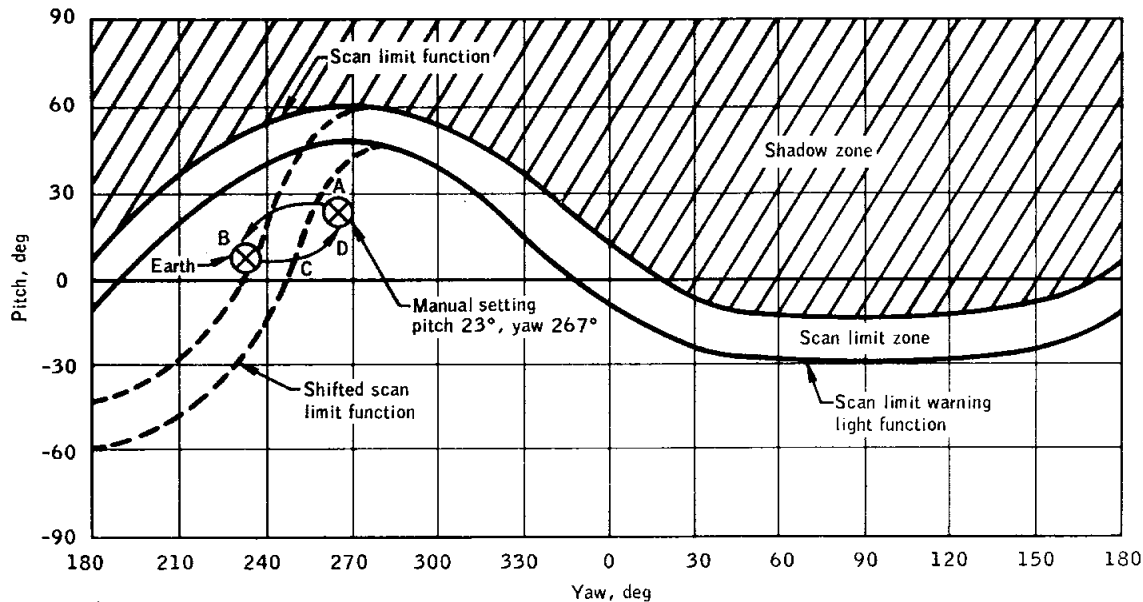
Figure 14-5.- Shift in scan-limit, scan-limit-warning illustrated.

mode and drive back toward the manual settings until the scan limit warning function line at point C was reached, thereby maintaining wide-beam operation. When the antenna reaches the scan limit warning function line, the system would automatically switch to the medium-beam mode and continue to drive in the manual mode until the manual setting error was nulled out at point A. The antenna would then switch to the auto-track mode and repeat the cycle. The most important feature of this cycle is that the antenna moves at the manual scan rate between points B and D, which is confirmed by the rapid changes in the downlink signal strength.

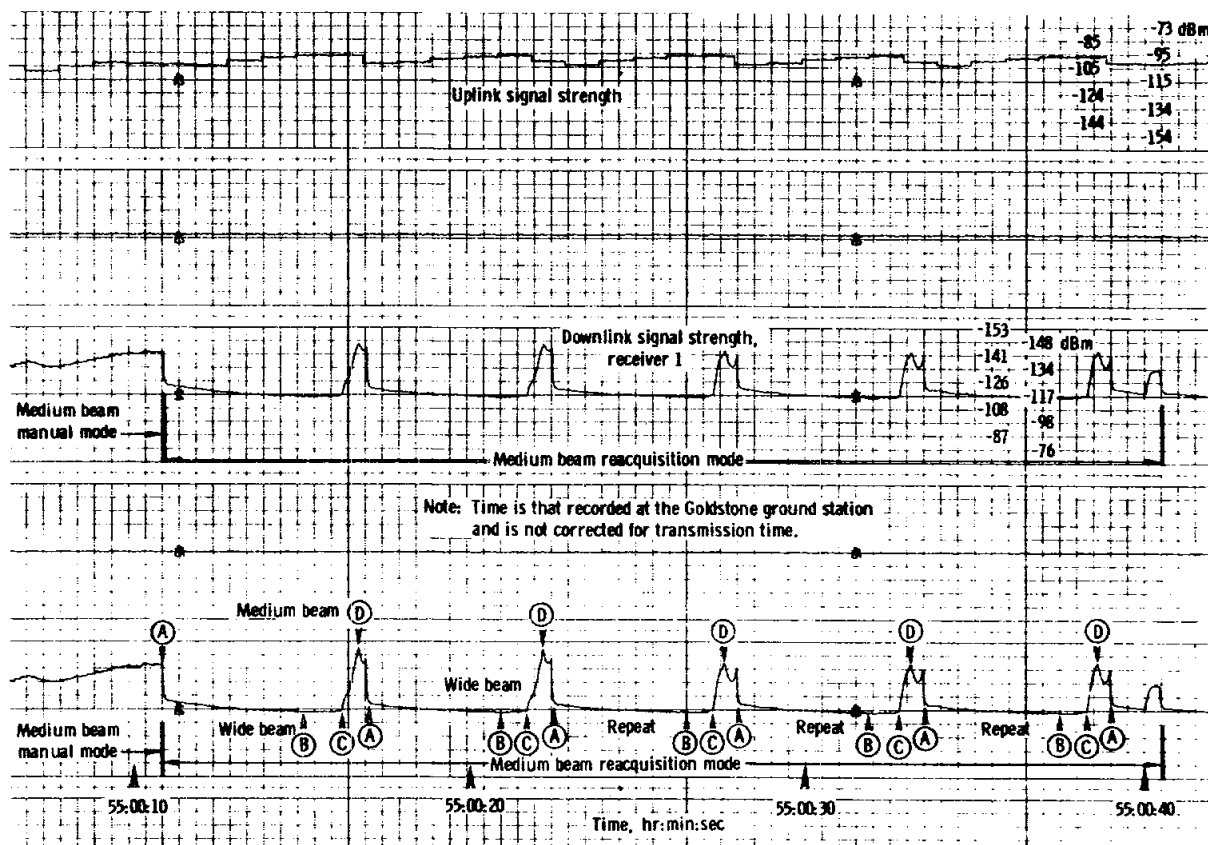
Figure 14-6.- Recorded signal strengths during high-gain antenna operation.

At approximately 56 hours, the high-gain antenna experienced an apparent switch from narrow to wide beamwidth, with a resultant temporary loss of telemetry data. This occurrence coincided with the oxygen tank pressure loss. Post-separation photographs of the service module show damage to the high-gain antenna, which is attributed to the loss of a service module outer panel. This damage, as discussed in reference 1, caused the beam switch and the resultant loss of data.

results of this test shifted the scan-limit functions but did not produce the necessary change in the scan-limit slope. Consequently, a failure in the electronic box is ruled out.

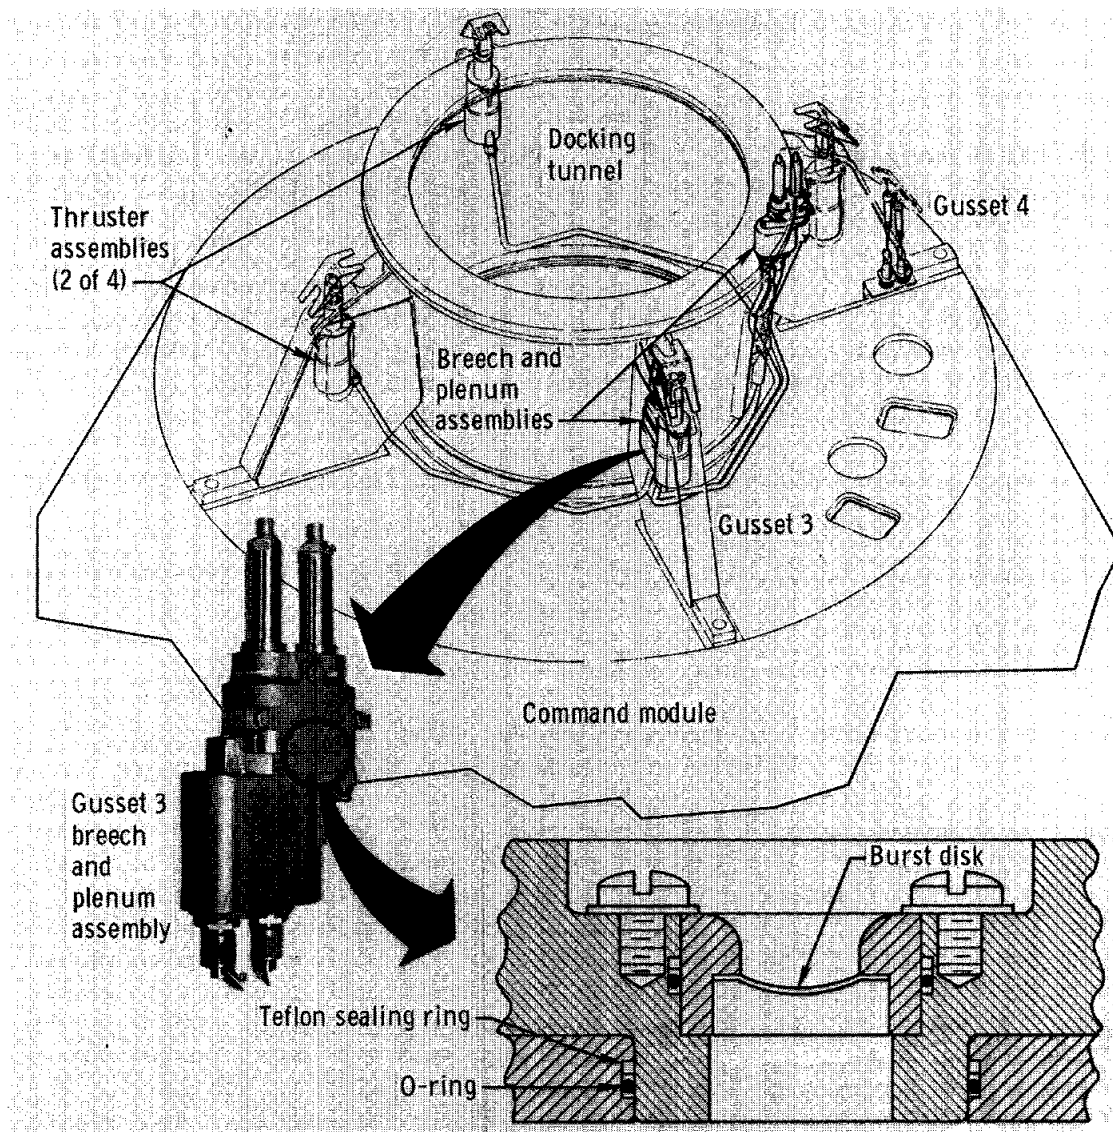
Figure 14-7.- Apex cover jettison system.

All mechanical systems functioned properly. One mechanical anomaly, however, was a gas leak from one of two breech assemblies in the apex cover jettison system, and this problem is discussed in section 14.1.6. In addition, docking tunnel insulation, which normally remains with the lunar module after separation, was noted from photographs to have cracked and expanded radially. Since the cracking is believed to occur during pyrotechnic firing and has been seen in past flights, it is not a problem.

- a. Out of tolerance parts - Measurement of the failed parts indicate acceptable dimensions of the metal parts.
- b. Damaged O-rings - The 21 000-psi static proof-pressure test was successful.
- c. Gap in backup ring - The installation procedure specifies the backup ring may be trimmed on assembly to meet installation requirements,

but does not specify any dimensional control over the scarf joint. Since the gap portion was burned away, a gap in the backup ring could have caused the problem.

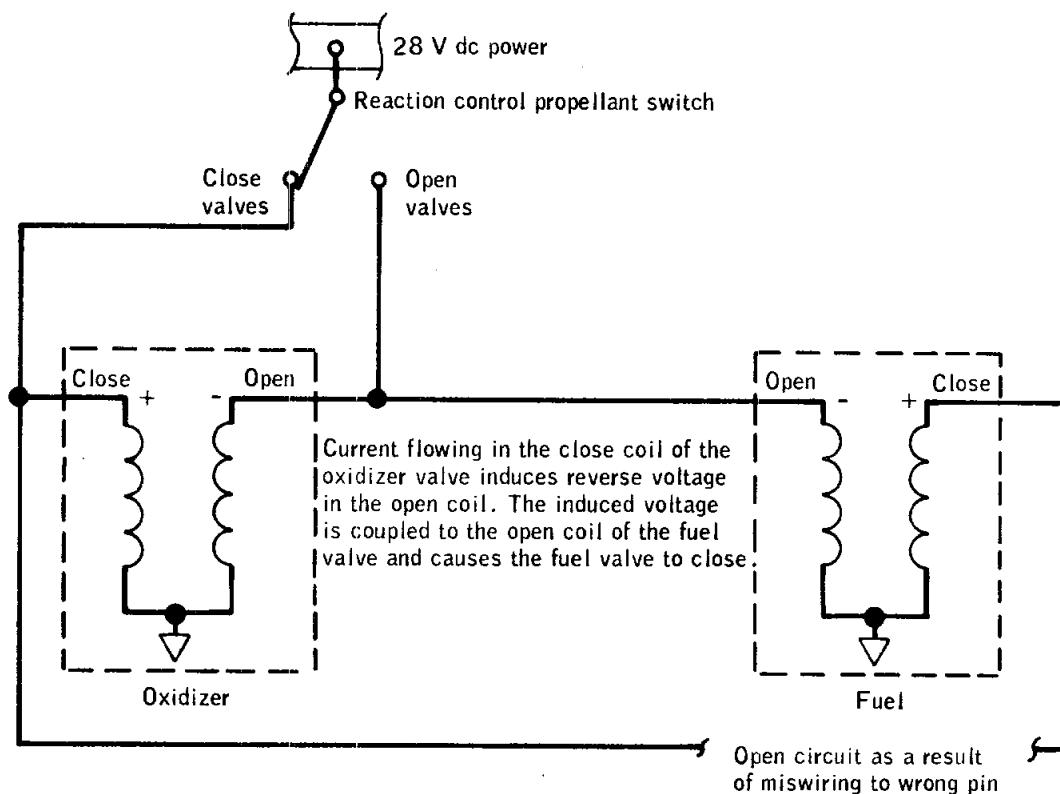
Figure 14-11.- Isolation valve circuit.

System decontamination at Hawaii was normal, except that the system 1 fuel isolation valve was found to be in the open position. All other propellant isolation valves were in the normal (closed) position. Power from ground servicing equipment was used to close the valve, which operated normally. Postflight investigation of this condition revealed that the electrical lead from the system 1 fuel-valve closing coil was miswired, making it impossible to apply power to this coil. This anomaly is discussed in section 14.1.7.

action. This voltage is applied to the fuel valve opening coil where it induces a magnetic field flux that closes the fuel valve. With 28 volts or more on the spacecraft bus, this phenomenon was consistently repeatable. With 24 to 28 volts on the bus, the valve would occasionally close, and with less than 24 volts, the valve would not close. Since preflight testing is accomplished at 28 volts, the functional tests did not disclose the miswiring. During the mission, the voltage was such that the valve did not close when commanded and therefore was found open after the flight.

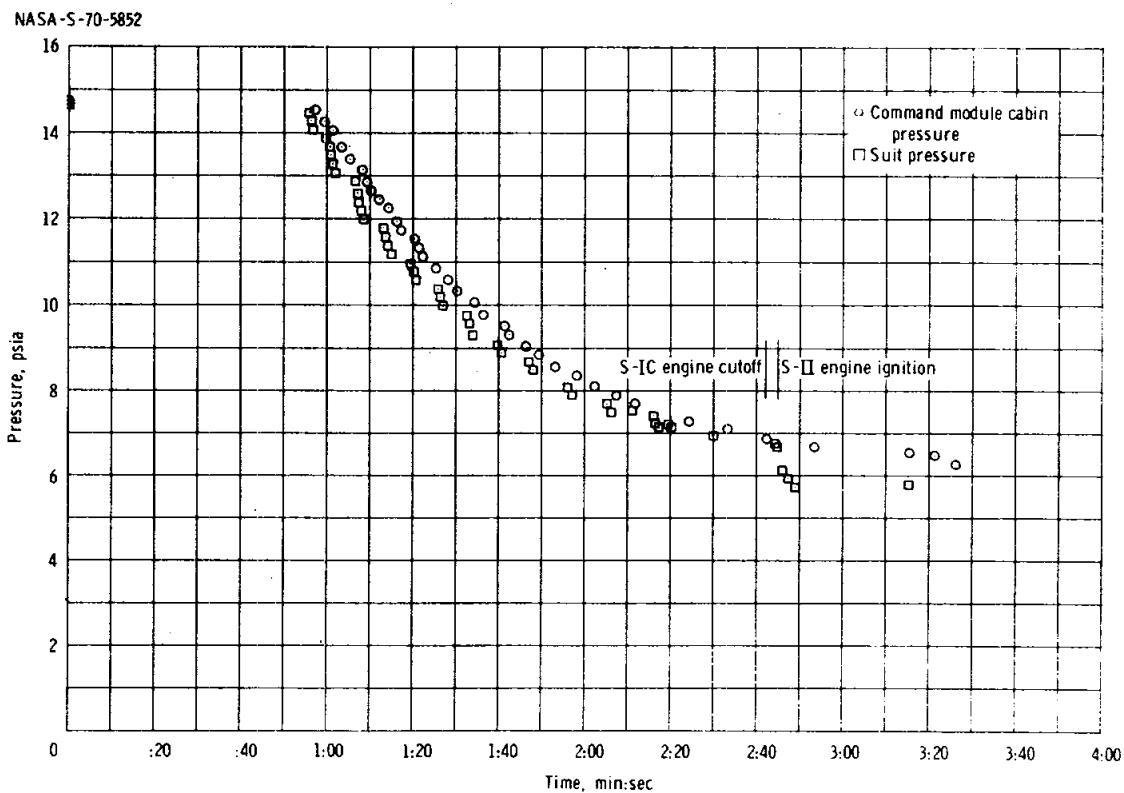
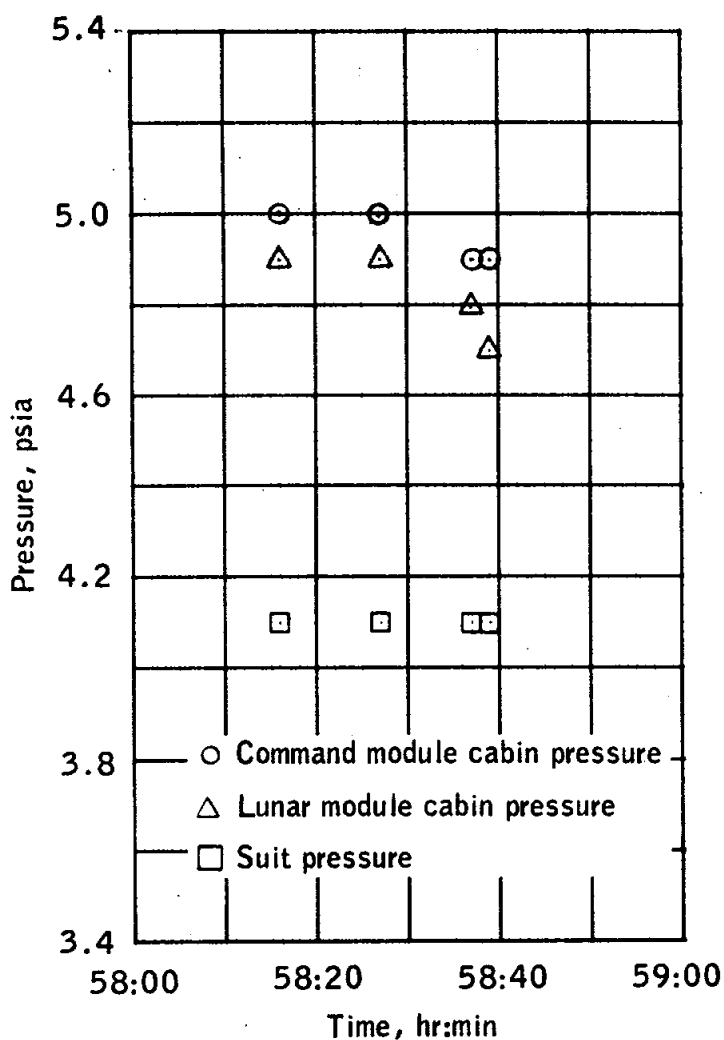
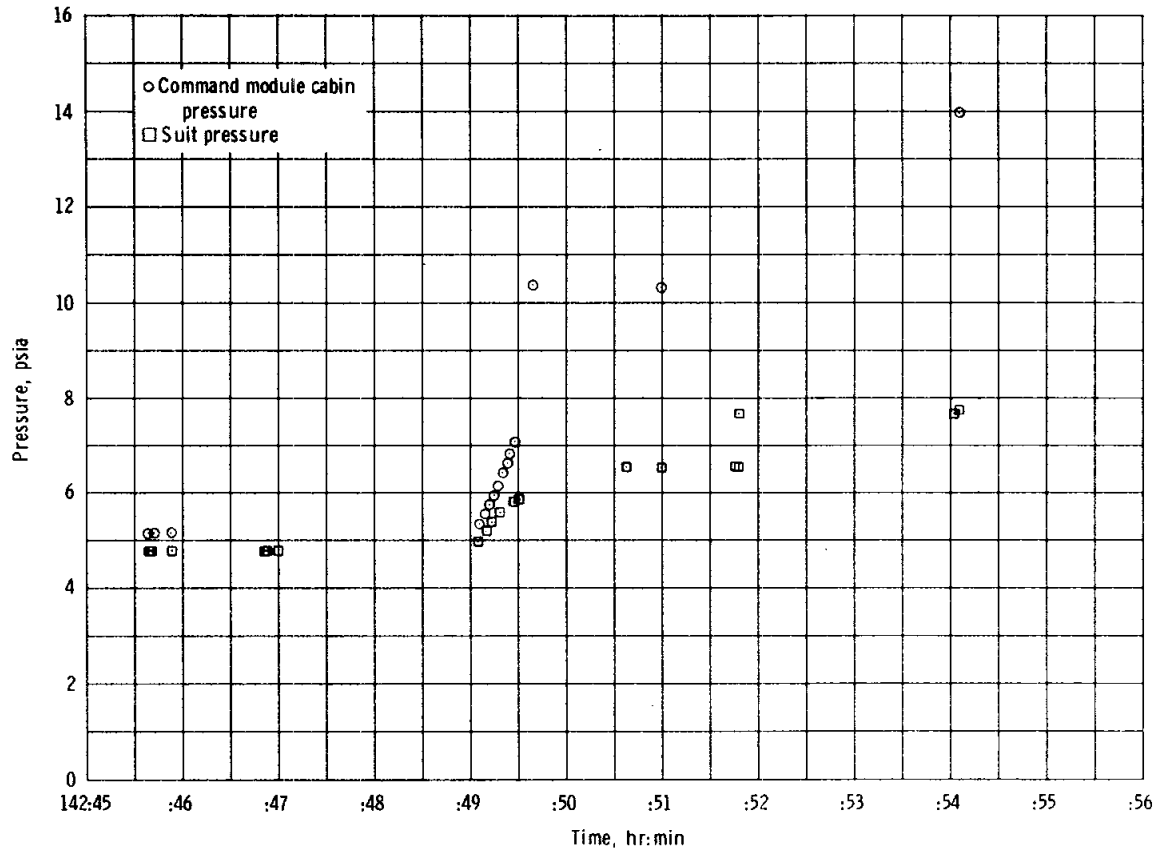
Figure 14-12.- Suit and cabin pressure.

During launch the suit pressure transducer reading remained consistent with cabin pressure until 00:02:45, then suddenly dropped from 6.7 to 5.7 psia coincidentally with S-II engine ignition (fig. 14-12). The difference between the two measurements decreased to only 0.2 by 1-1/2 hours, when the cabin reached its nominal regulated pressure of 5.0 psia. For this shirtsleeve mode, the suit and cabin pressure readings should be nearly equal. During normal variations in the command module cabin pressure, the suit pressure measurement responded sluggishly and indicated as much as 1 psi low. Subsequently, the measurement output decayed and remained in the 4.1 to 4.3 psia range for a cabin pressure of 5.0 psia until system deactivation at about 59 hours (fig. 14-12).

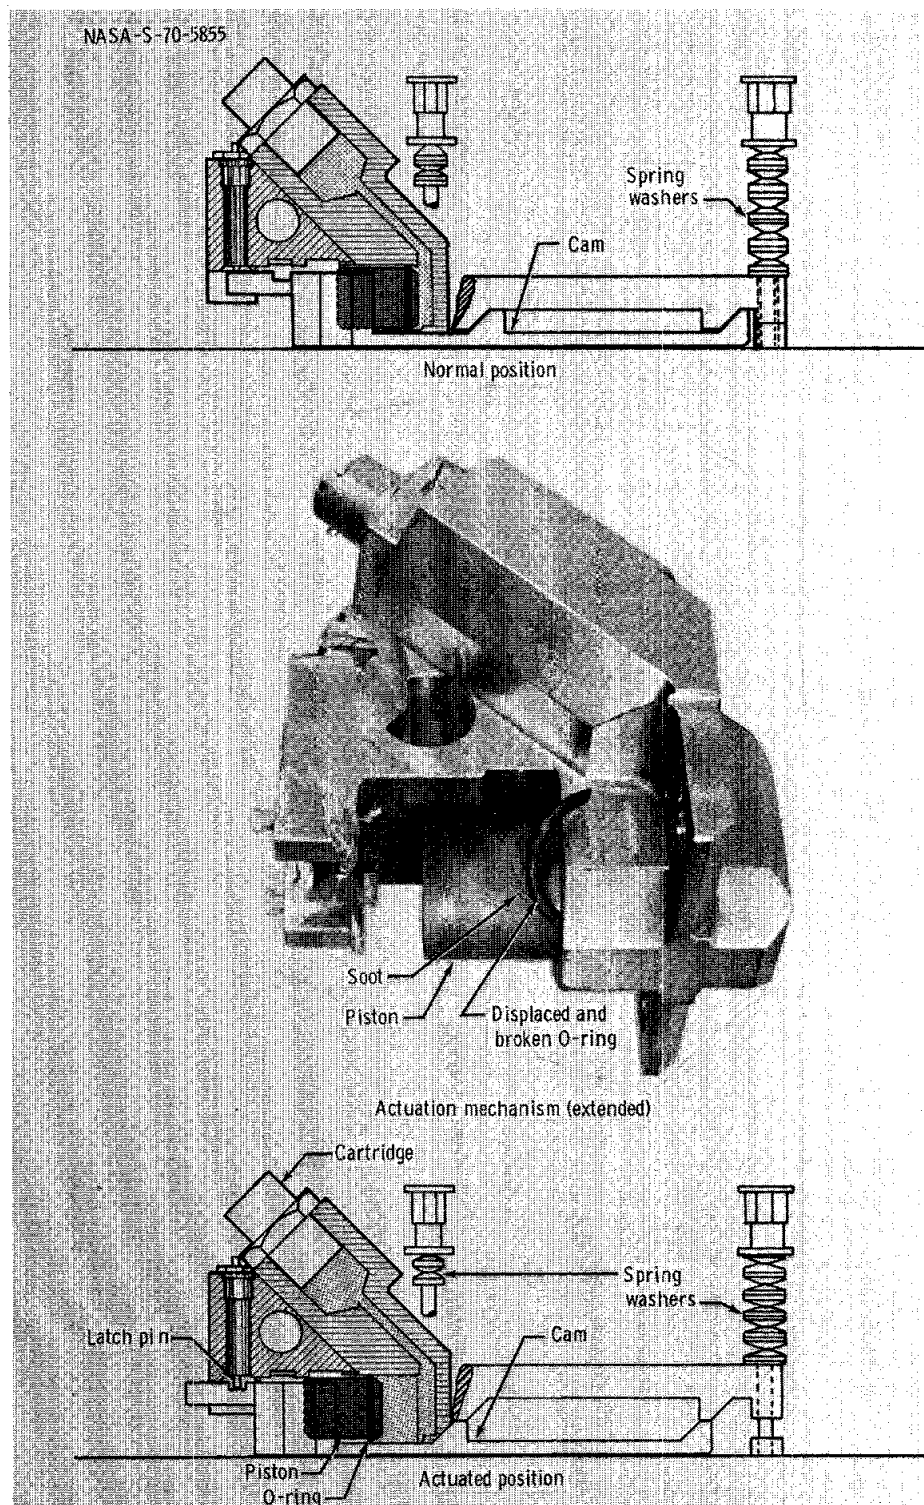
Figure 14-13.- Circuit interrupter.

The two interrupters open the electrical circuits about 30 milliseconds before the wires are severed by the command module/service module umbilical guillotine. As illustrated in the figure, a cam fork is moved by a piston, which is operated by propellant gas from redundant cartridges, to function a lift plate. Motion of this plate disconnects the male and female portions of electrical connectors located, respectively, in the lift plate and in the base plate of the interrupter. At the completion of the stroke, the fork is brought to rest by impacting and crushing an aluminum block mounted on the interrupter housing.

The worse-case tolerance buildup is when the fork contacts the attenuator block and the piston O-ring is 0.075 inch from entering the chamfer in the breech assembly. The O-ring enters this chamfer when the block has been crushed about 94 percent, at which point an O-ring displacement and accompanying gas escape could be expected. The factors which affect the degree of attenuator crushing are generally uncontrollable within narrow limits and include:

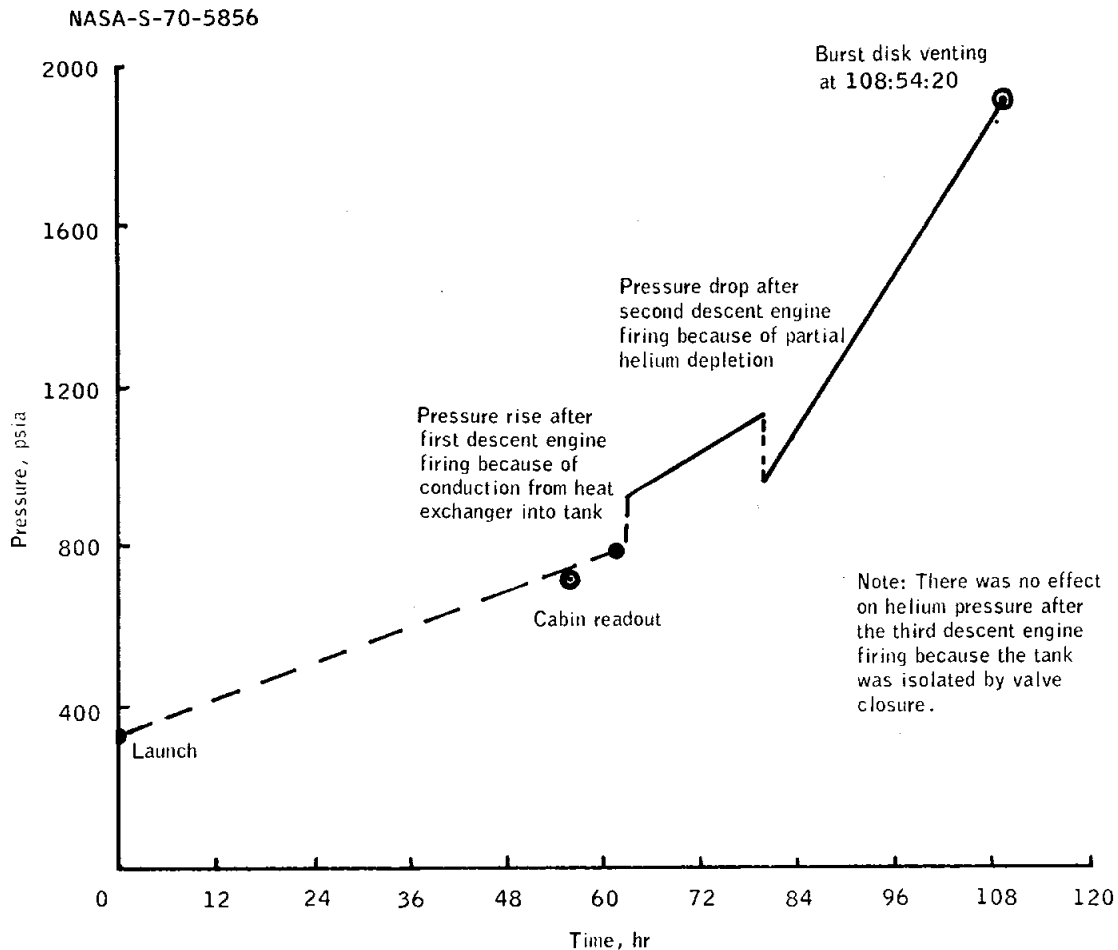
Figure 14-14.- Inflight profile of supercritical helium tank pressure.

The most likely cause of the anomaly is a tank-insulation degradation which would result in increased heat conduction to the helium. The insulating characteristics of the annular vacuum in tank was most likely degraded by the introduction of a contaminant (probably hydrogen) in extremely small concentrations (approximately 10^{-6} pounds). These contaminants when vaporized can exponentially increase the thermal conductivity in proportion to their vapor pressure, as indicated by special tests. While loading helium into the tank, the contaminants would freeze upon the inner shell. In the frozen state, the pressure of the contaminant is too low to significantly affect the thermal conductivity. However, the flow check which preceded the cold-soak operation would vaporize the contaminants in the vicinity of the heat exchanger lines which pass through the annulus. The subsequent increase in thermal conductivity could cause the abnormally high pressure-rise rate observed during the cold soak. These vapors would slowly condense on the cold (10° R) inner wall, resulting in the pressure rise rate dropping to the nominal level, as was observed. The rise rate would remain normal until the helium temperature increased above the vaporization temperature of the contaminant.

A screening test was devised for all future flight tanks to supplement normal helium tank testing. The purpose of this test is to determine the pressure rise rate for a wide range of helium temperatures from approximately 9° to 123° R. For a perfect tank, the steady-state rise rate should remain at approximately 8 psi/hour over the entire range of temperatures. The Apollo 14, 15, and 16 tanks have been subjected to the screening test, and each exhibit the same phenomena observed during Apollo 13, but to a lesser degree. For new tanks, the manufacturer will periodically analyze the gases removed from the vacuum jacket during pump down for possible contaminants. The pressure in the jacket will be measured 2 or 3 weeks after pumpdown to verify vacuum integrity.

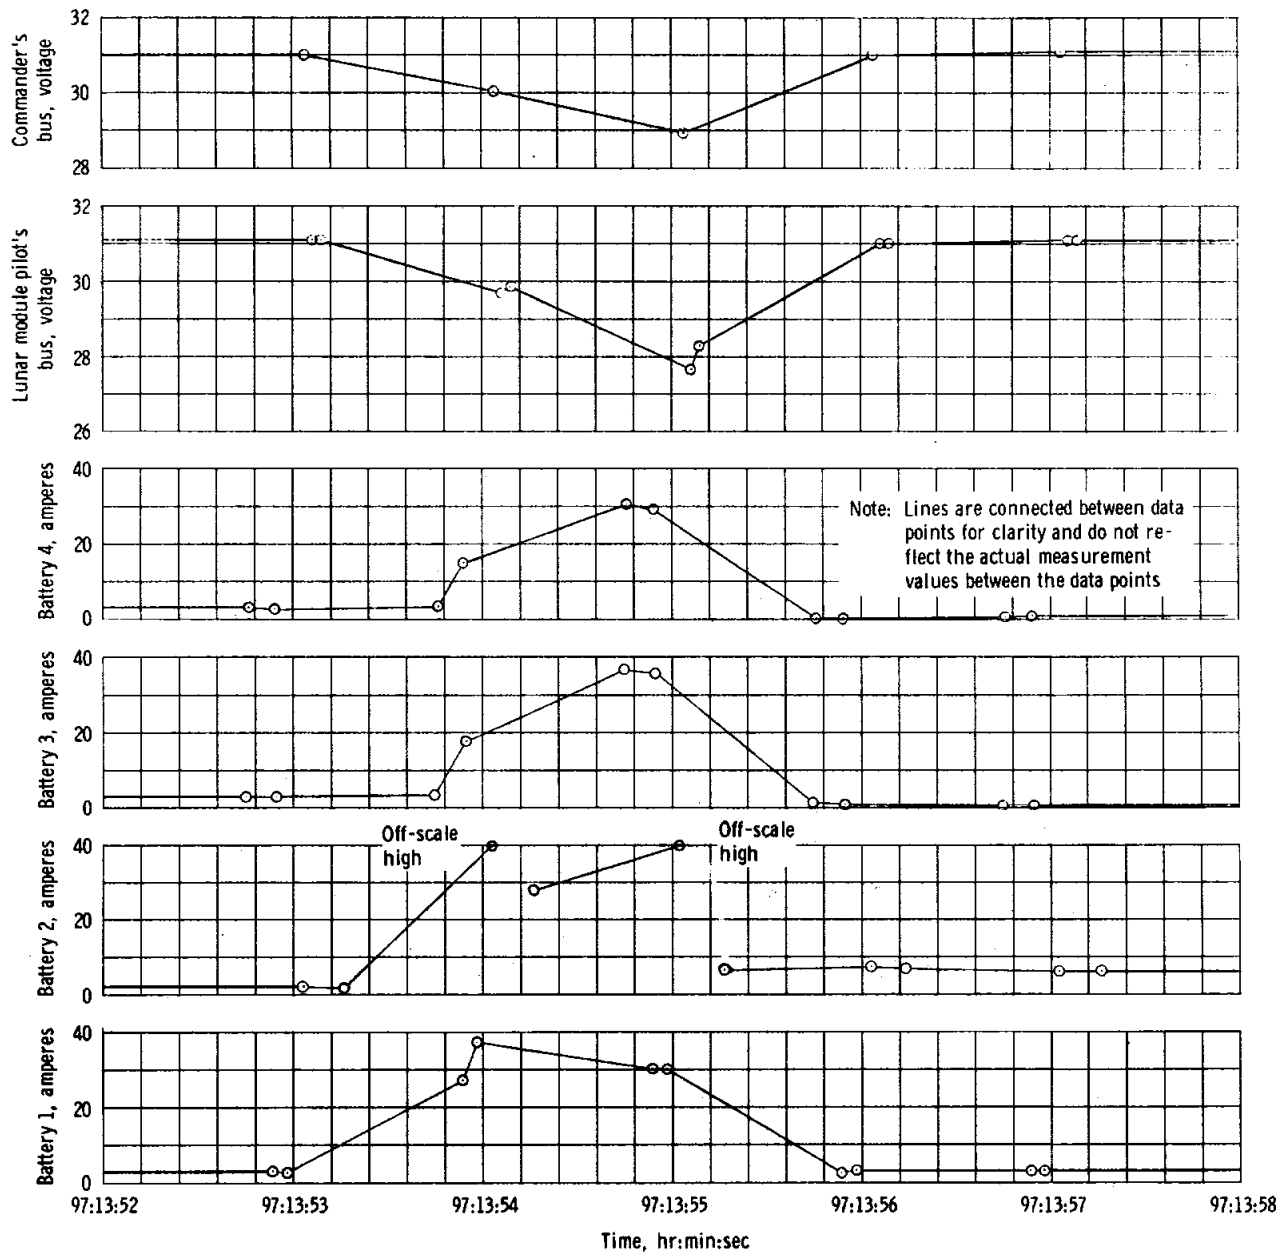
Figure 14-16.- Battery electrical transients.

The thumping noise occurred at about the same time as the current spikes. The current spikes show that a momentary short circuit existed in the Lunar-Module-Pilot side of the dc electrical system, which includes descent batteries 1 and 2 (fig. 14-16). The current surge was not of sufficient duration either to open the balance-load cross-tie circuit breakers, to display a reverse current indication, or to trip a battery-off relay as a result of an overcurrent condition.

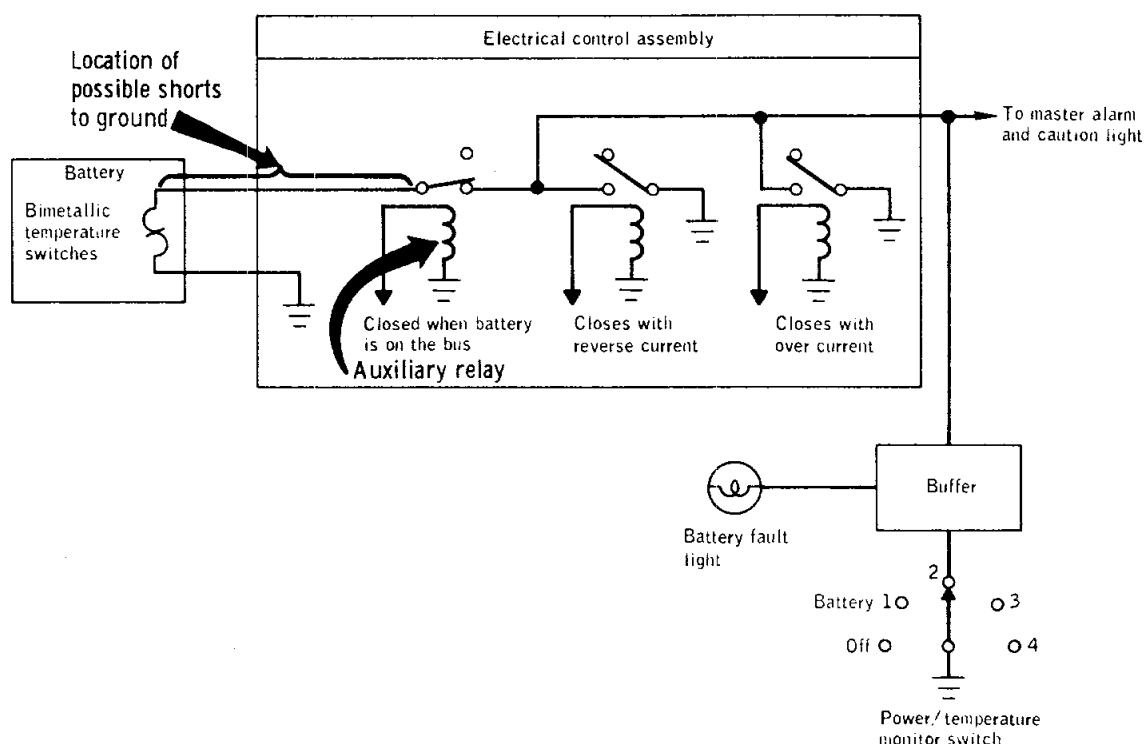
Figure 14-18.- Battery 2 malfunction circuit.

A battery overcurrent can be ruled out because automatic removal of the battery from the bus would have occurred.

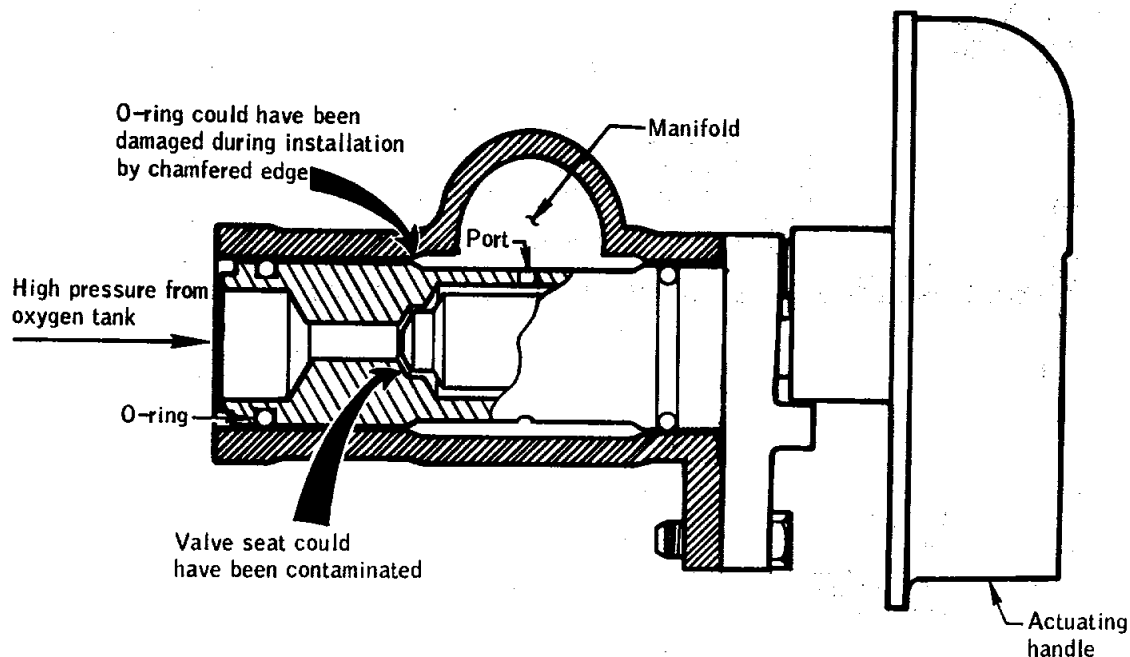
Figure 14-20.- Ascent stage tank shutoff valve.

The internal portion of three valves of this type had been replaced previously on the spacecraft because of excessive leakage through the ascent oxygen tank 1 shutoff valve. In one valve, a rolled O-ring

compression allowed in the valve design would aggravate the tendency for the O-ring to roll during valve assembly.
