NATIONAL AERONAUTICS AND SPACE ADMINISTRATION

APOLLO 13 MISSION REPORT

MANNED SPACECRAFT CENTER

SEPTEMBER 1970

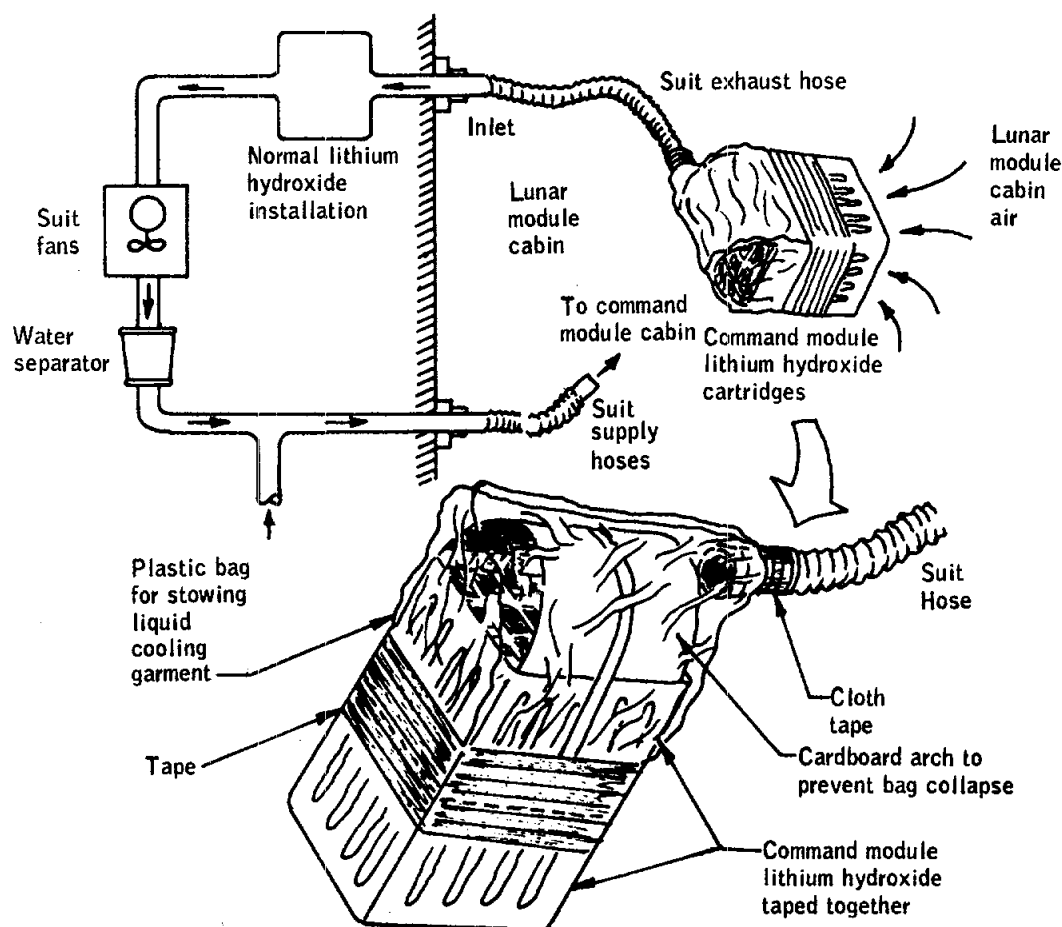
Figure 6.7-1.- Supplemental carbon dioxide removal system.

It became apparent that there were insufficient lithium hydroxide cartridges in the lunar module to support the abort mission, even with allowable carbon dioxide levels extended to a partial pressure of 15 mm Hg. With ground instructions, a system was constructed which attached a command module lithium hydroxide cartridge to each of two lunar module suit hoses. The Commander's remaining hose was placed in the tunnel area to provide fresh oxygen to the command module, while the Lunar Module Pilot's remaining hose was positioned in the lunar module environmental control area. At a later time, a second cartridge was added in series to the cartridges initially installed, as shown in figure 6.7-1. In each case, the drop in carbon dioxide levels reported by the ground showed satisfactory operation of this improvised carbon dioxide removal system.

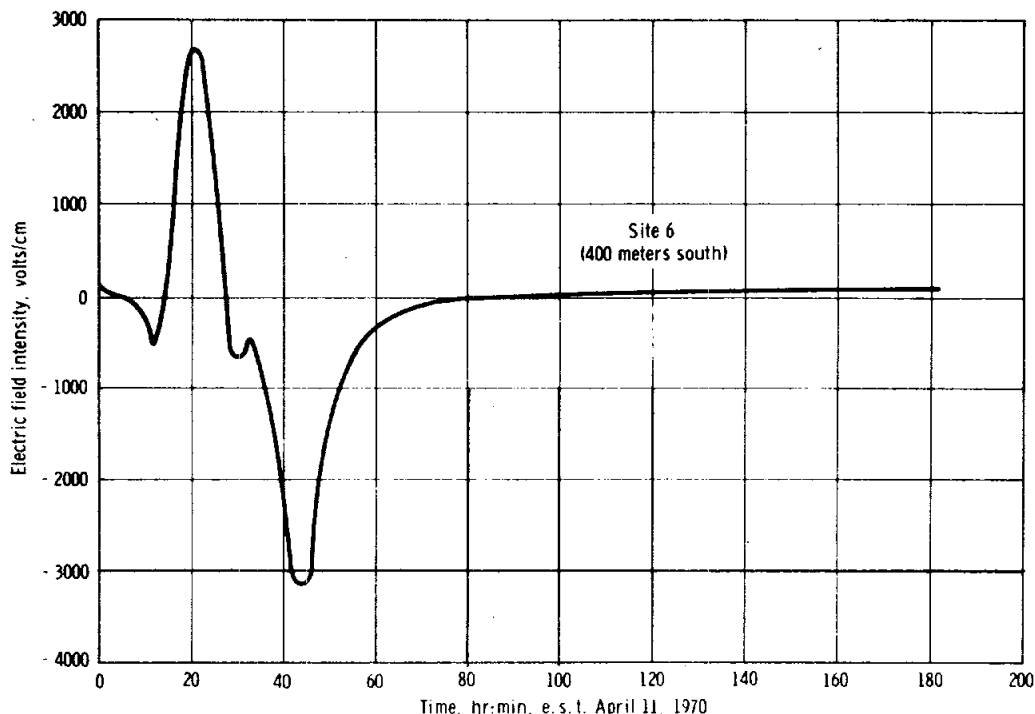
(b) Site 6.

At site 6, the record was similar to that for site 7 with an initial positive excursion followed by a slower negative change. At this station, however, there were large fluctuations superimposed on the record, as shown in figure 11.1-3(b). These fluctuations could have been caused by

gravel and dust stirred up by the exhaust of the launch vehicle engine. After launch, a quantity of such debris was found near the surface of the field meter and its surrounding area. After the oscillations had subsided at T plus 40 seconds, there was a large negative field of approximately minus 3000 volts/meter which probably resulted from the exhaust and steam clouds that tended to remain over site 6.

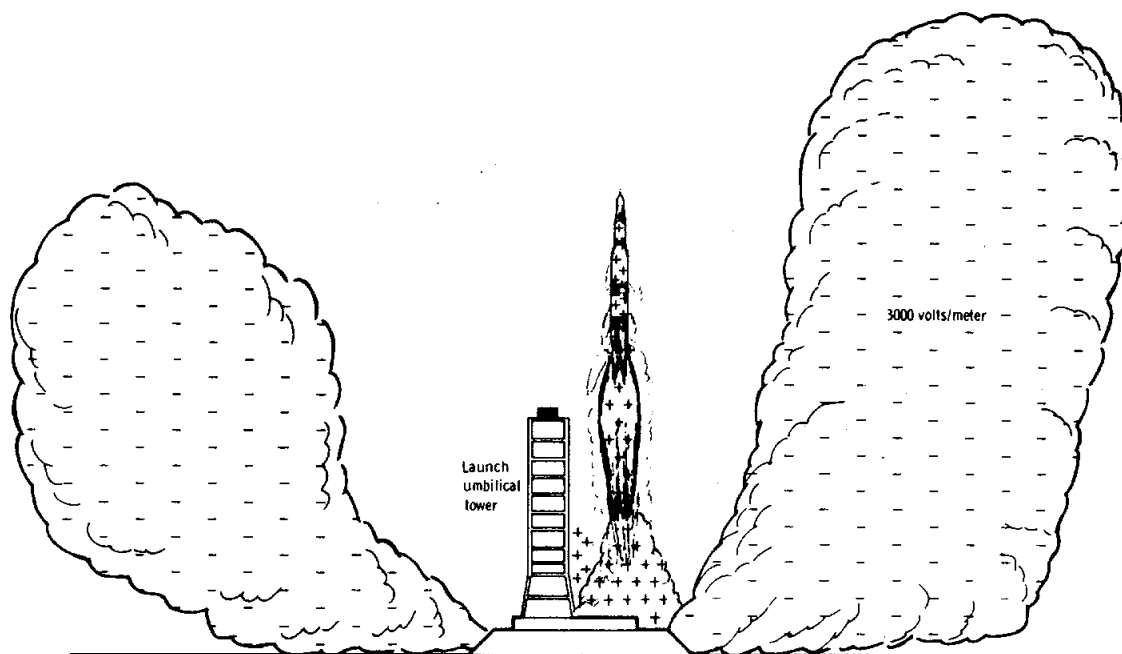
Figure 11.1-4.- Electrical charge characteristics.

Field meter records indicate the Apollo 13 vehicle carried aloft a net positive charge and that the trailing exhaust gases were negatively charged (fig. 11.1-4). Initial analysis indicates the total charge Q carried by the vehicle was about 0.04 coulomb. If the capacitance of the launch vehicle is about 100 picofarads, the vehicle is then at a potential of 4 million volts. A stored charge of 0.04 coulomb at a potential of 4 million volts provides an electrostatic potential energy of 160 000 joules. Although this energy is much less than that dissipated

in a natural lightning discharge, the level is still considerable and could significantly increase the potential hazard in an otherwise marginal weather situation. These numbers are consistent with the electrostatic discharge analysis performed on the Apollo 12 lightning incident. Engines in jet aircraft have been observed to produce similar charging effects.

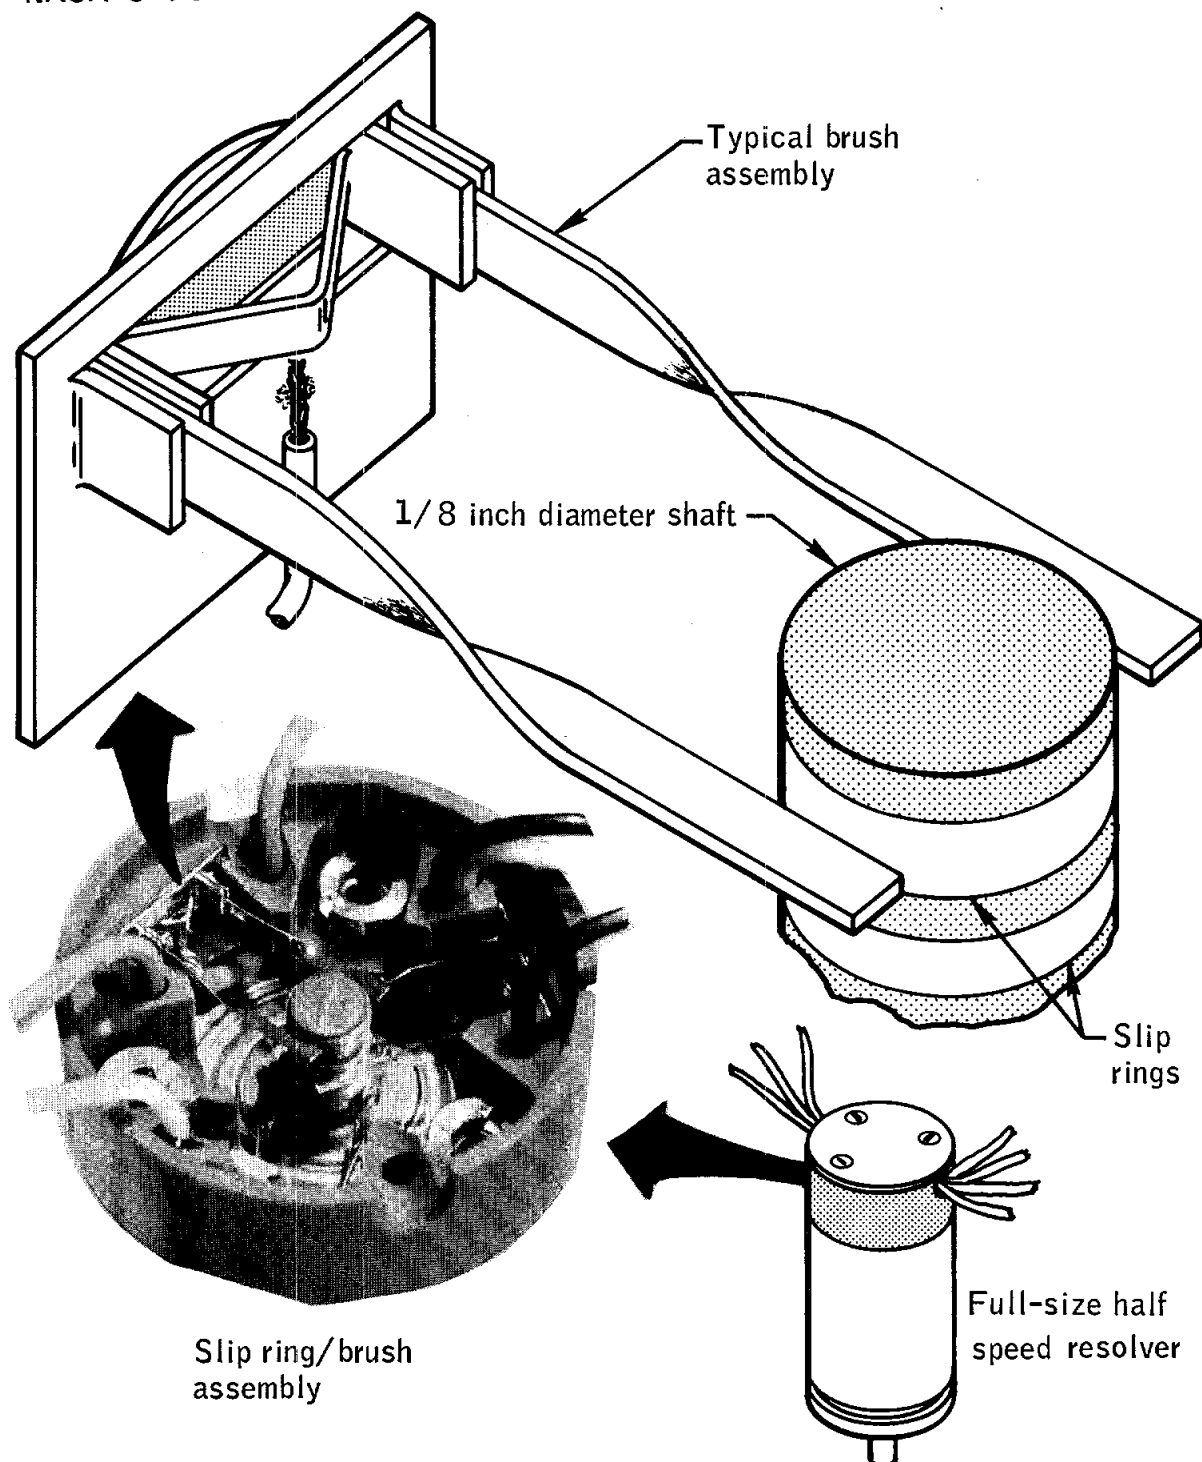
Figure 14-3.- Details of half speed resolver.

The most likely candidate is the half-speed resolver, which is used only for the shaft axis and only to provide an unambiguous zero reference. The reference voltage is applied to the rotor through slip rings (fig. 14-3), connected as shown in figure 14-4. If any resistance is present in the common ground path through the slip ring, a portion of the reference voltage will appear across the quadrature winding and induce a finite output (different than zero). Zero output is equivalent to zero degrees in shaft rotation.

Some evidence of susceptibility to vacuum was exhibited in this class of resolvers during qualification testing when variations of approximately 5 ohms were observed in the slip ring resistance during thermal

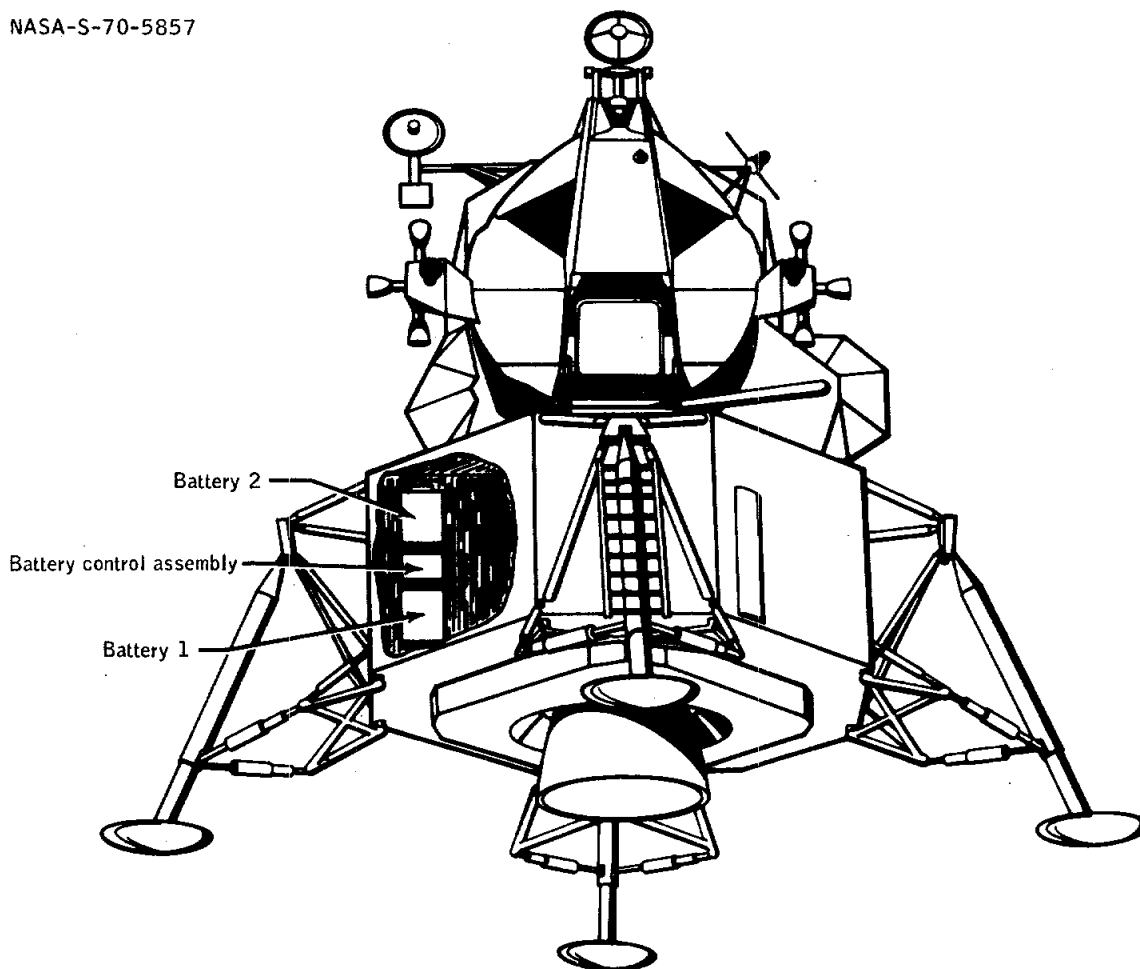
Figure 14-15.- Descent stage battery location.

At 97 hours 14 minutes, the crew reported a thumping noise and snowflakes venting from quadrant 4 of the lunar module descent stage (fig. 14-15). All four descent batteries experienced current transients at 97:13:53 for about 2 seconds, with corresponding drops in dc bus voltage (fig. 14-16). Also, the water glycol pressure differential for the heat transport system decreased momentarily, indicating that the glycol pump momentarily slowed down.

The thumping noise occurred at about the same time as the current spikes. The current spikes show that a momentary short circuit existed in the Lunar-Module-Pilot side of the dc electrical system, which includes descent batteries 1 and 2 (fig. 14-16). The current surge was not of sufficient duration either to open the balance-load cross-tie circuit breakers, to display a reverse current indication, or to trip a battery-off relay as a result of an overcurrent condition.

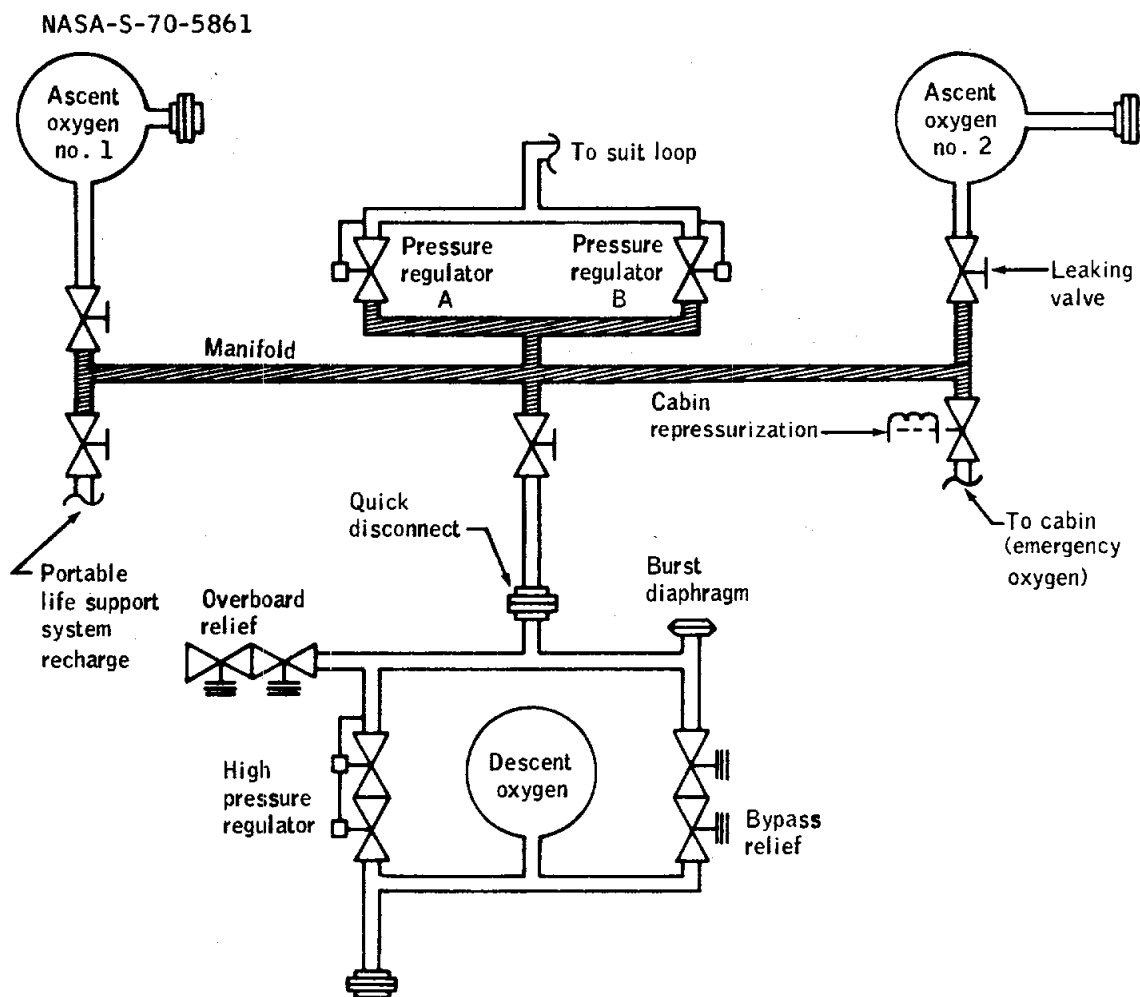
Figure 14-19.- Oxygen-supply system.

During the flight, the pressure in the ascent stage oxygen tank 2 increased, indicating a reverse leakage through the shutoff valve from the oxygen manifold (fig. 14-19) into the tank. The leak rate, with a maximum differential pressure of 193 psi, varied from about 0.22 lb/hr (70 000 scc/hr) to zero when the tank pressure reached manifold pressure. Allowable leakage for the valve in either direction is 360 scc/hr. Pre-flight test data indicate a reverse leakage of 360 scc/hr and no excessive leaking in the forward direction.

The internal portion of three valves of this type had been replaced previously on the spacecraft because of excessive leakage through the ascent oxygen tank 1 shutoff valve. In one valve, a rolled O-ring

(fig. 14-20) caused the leakage. When the valve is installed, the forward O-ring can be rolled and damaged when it passes the manifold port. In the other two valves, the cause was not identified and was assumed to be contamination.
